MILESTONE PHASE 1 CONDITION SURVEY REPORT

Parkwood Square Apartments – Building B

5880 38th Avenue North, St. Petersburg, FL 33710

**Subject: Milestone Phase 1 Structural Condition Survey Report
Parkwood Square Apartments B
5880 38th Avenue North
St. Petersburg, FL, 33710**

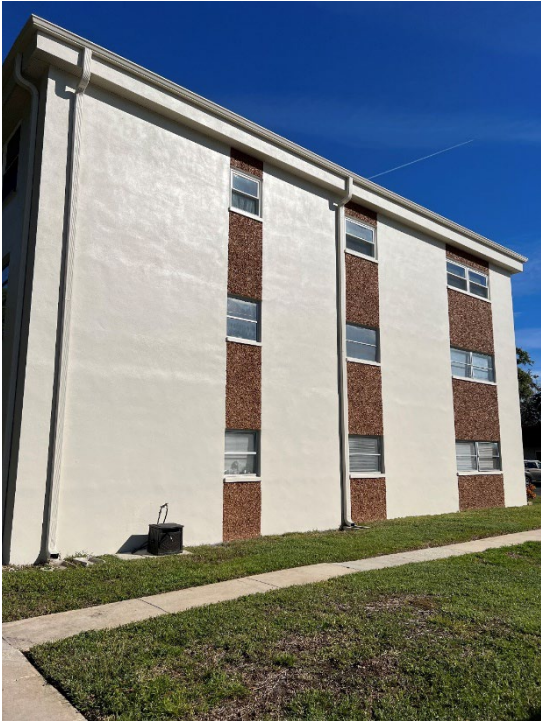
Figure A-1

1. South elevation, East elevation, North elevation, and West elevation exterior wall areas are shown in *Figure A-1* through *Figure A-4*, respectively.
2. A Column supporting the Porte Cochere entry roof area at the center of the east elevation exhibited excessive stucco delamination on the south face and east face of the column.
3. Delaminated stucco was detected on the Porte Cochere beam.
4. Numerous areas of stucco delaminations were detected throughout the accessible exterior walls and exterior wall areas adjacent to the walkways.
5. Multiple cracks were noted on the exterior walls. Refer to *Figure A-5* and *A-6*.

Based on the detection of multiple areas of stucco delamination and cracks within the exterior walls, BillerReinhart recommends a restoration project be undertaken for the repair and maintenance of all the exterior wall surfaces including deteriorated concrete structural elements, stucco, sealants, and touch-up building painting. Restoration of the exterior wall areas should mitigate potential moisture intrusion and expose any structural deterioration of underlying structural elements in need of repair. BillerReinhart recommends the exterior wall restoration and waterproofing project be undertaken within the next 1-2 years.

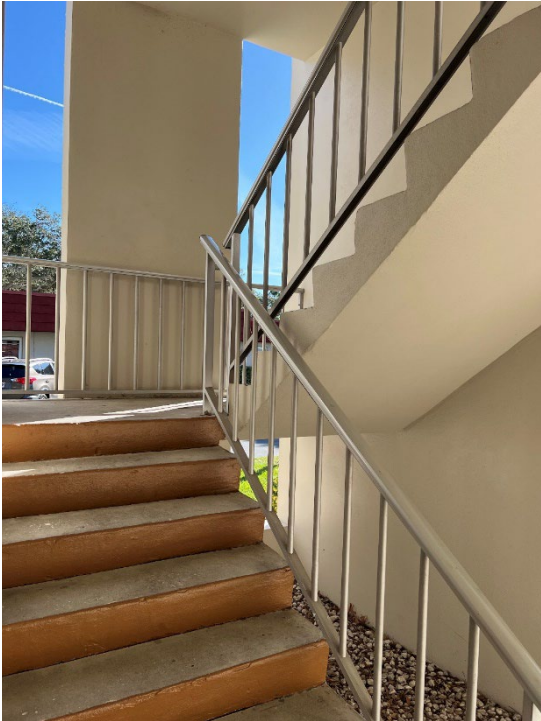
Figure A-7

1. The stairwells were generally observed to be in fair condition. Refer to *Figure A-7*.

The stairwell structures appear to be in good condition. BillerReinhart recommends periodic maintenance and painting with proper surface preparation of the stairwell handrails and metal members to prevent corrosion formation. Original guardrails to be replaced along with the walkway guardrail replacement project.

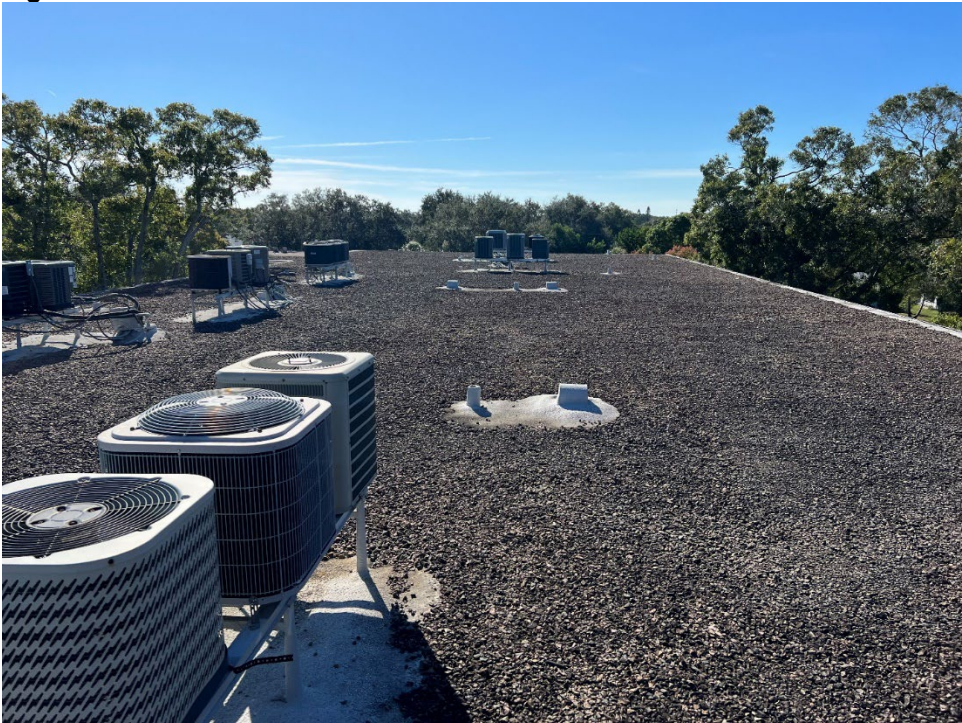
Figure A-8

1. The roof was generally observed to be in fair condition. An overall view of the roof can be seen in *Figure A-8* through *Figure A-10*.

The existing SPF roof system with foam over the top was generally observed to be in fair condition with no reports of water intrusion. BillerReinhart recommends continually monitoring the conditions of the roof and performing maintenance of the new roof system as the need arises and plan to replace with a new roof in approximately 15 years.

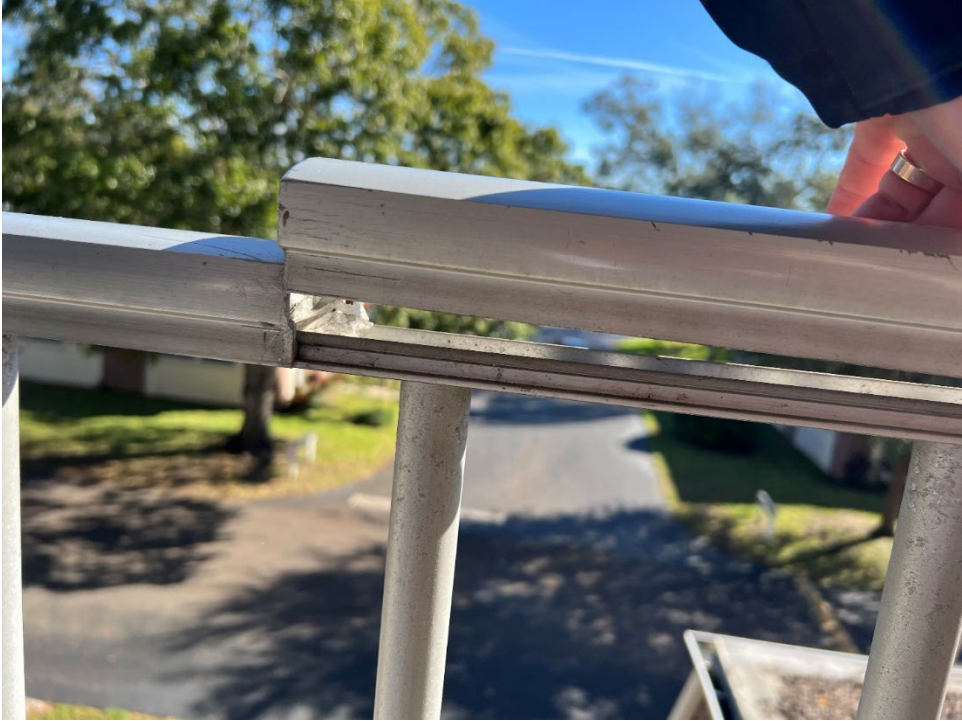
Figure B-1

2. Excessive out-of-plane displacement of guardrail segments were observed when lateral load was applied to the handrail throughout the assemblies.
3. A segment of the handrail cover was observed to be detached. Refer to *Figure B-1*.

with the existing guardrails exceeding 50 years of age. The existing original guardrails are beyond their normal life expectancy. Based on observations of detached handrail segments and excessive out-of-plane displacement of the guardrails when applied with a lateral load, made during the condition survey, BillerReinhart recommends the guardrails be replaced as soon as possible. BillerReinhart recommends monitoring the conditions until the replacement project can be completed.

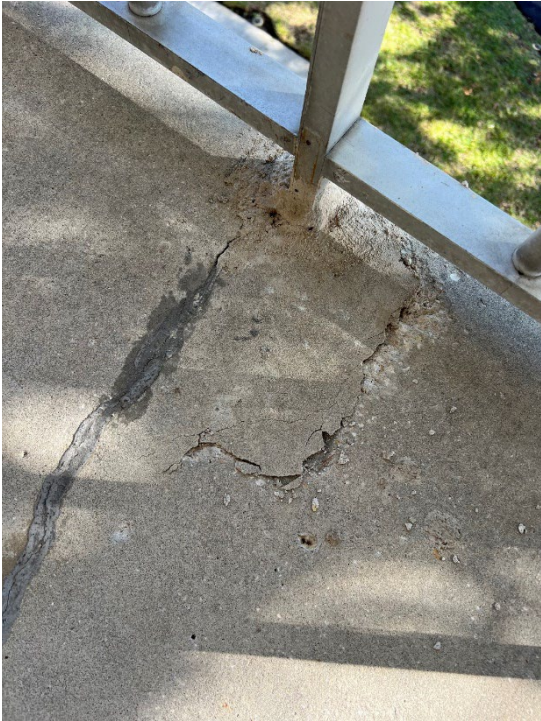
Figure B-2

4. Sporadic slab edge delaminations were observed throughout the walkway. Refer to *Figure B-2*.
5. Corrosion of the picket fasteners was observed throughout the underside of the guardrail's toeplate. Refer to *Figure B-3*.

The walkway structures generally appear to be in fair condition with sporadic slab delaminations on the top surfaces, ceilings and slab edges and sporadic cracking throughout. BillerReinhart recommends the board plan for a global walkway waterproofing and restoration project to be performed. This would include restoration of the structural deck and application of a urethane waterproofing membrane. Urethane waterproofing membranes can withstand the pedestrian traffic that occurs on the balconies and provide the flexibility to expand and contract with the building movements to better protect the concrete structure from potential moisture intrusion and any structural deterioration of underlying structural elements. BillerReinhart recommends performing the global walkway waterproofing and restoration project in conjunction with the exterior wall restoration project unless conditions warrant an earlier date.

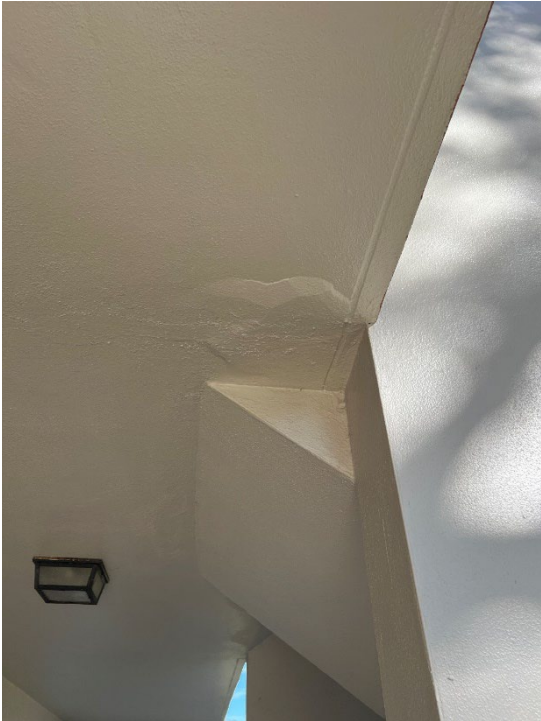
Figure B-4

6. Ceiling and slab edge spalling was observed adjacent to Unit 105. Refer to *Figure B-4*.
7. Sporadic walkway slab edge spalling with exposed corroded reinforcement was observed throughout the walkway structures. Refer to *Figure B-5*.

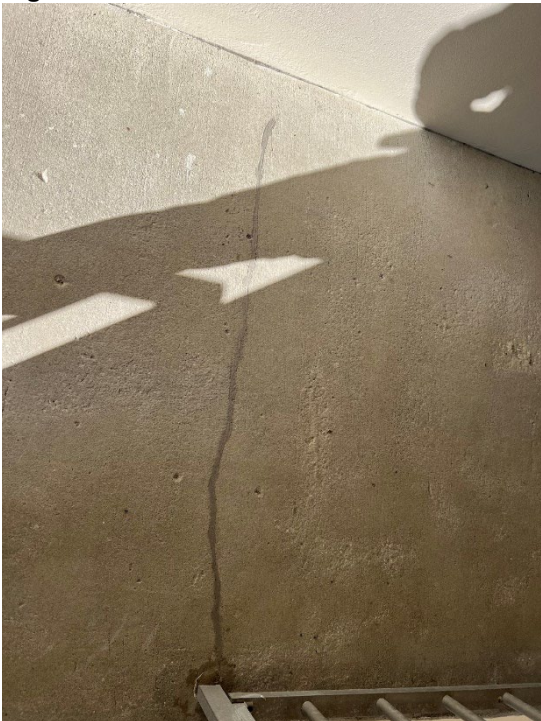
Figure B-6

8. Sporadic cracking was observed throughout the top surface of the walkway slabs. Refer to *Figure B-6*.
9. Delaminated stucco was detected in the stucco wall finish adjacent to the walkways.
