# MILESTONE PHASE 2 CONDITION SURVEY REPORT

Parkwood Square Apartments – Building B

5880 38<sup>th</sup> Avenue North, St. Petersburg, FL 33710

**Subject: Milestone Phase 2 Structural Condition Survey Report  
Parkwood Square Apartments B  
5880 38<sup>th</sup> Avenue North  
St. Petersburg, FL, 33710**

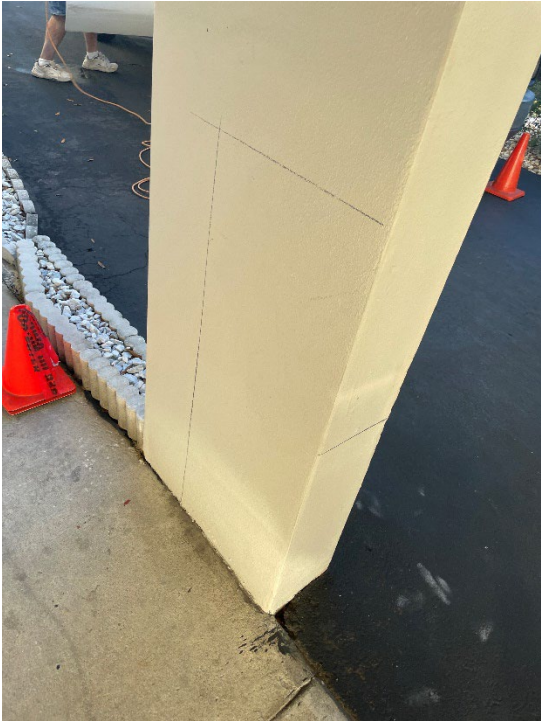
Figure A-2

1. The Contractor was directed to remove the identified areas of delaminated stucco of the column located at the east elevation Porte Cochere ground level column.
2. The Contractor marked the areas to be excavated and utilized a hand saw to remove the marked areas. Refer to *Figure A-1* and *Figure A-2*.
3. BillerReinhart reviewed the exposed structural concrete. No signs of structural concrete deterioration were present on the exposed concrete surfaces. Refer to *Figure A-3* and *Figure A-4*.
