## Windstorm Mitigation Report (OIR-B1-1802)

Parkwood Square Apartments Association B, Inc.

5880 38th Ave N, Units 101-311

As of 08-11-2025 | FPAT File# MUD2525063

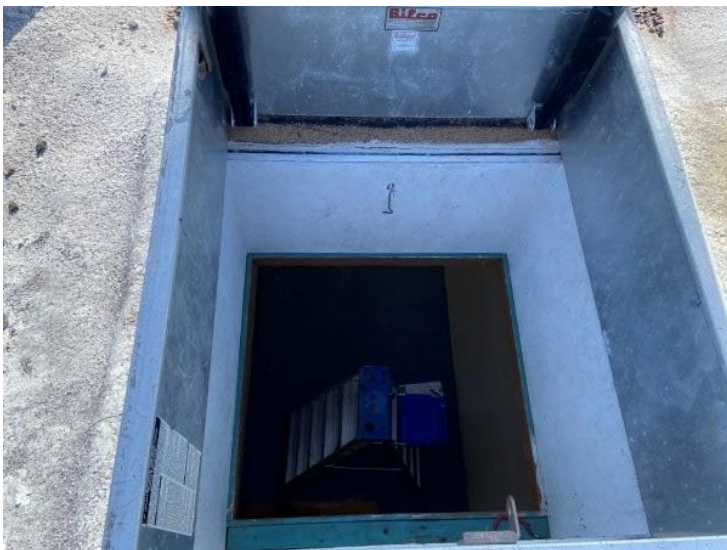
Roof Permit  
Information

| <b>2. Roof Covering:</b><br>Comments: | <b>FBC Equivalent</b><br>The roof covering was replaced in 2002. The roof permit was confirmed and the permit number is 02-4000451. This roof was verified as meeting the building code requirements outlined on the mitigation affidavit. |

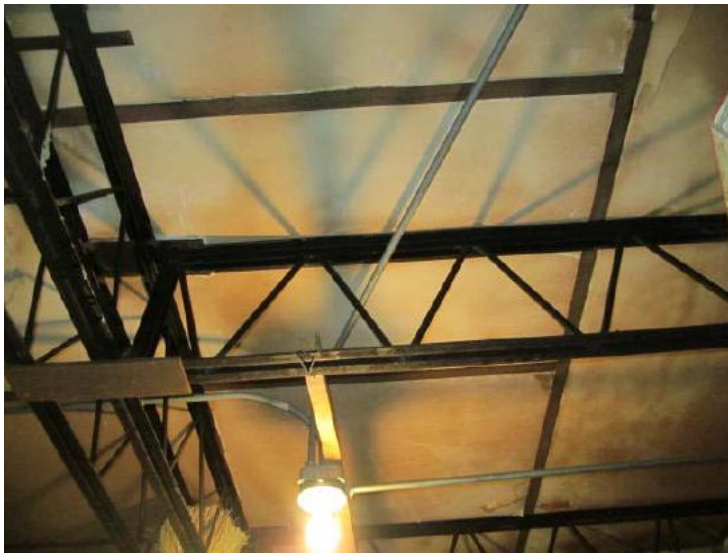
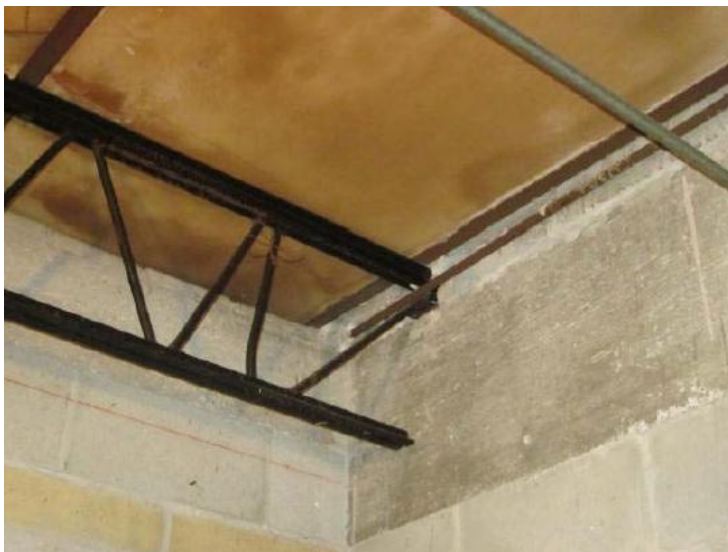
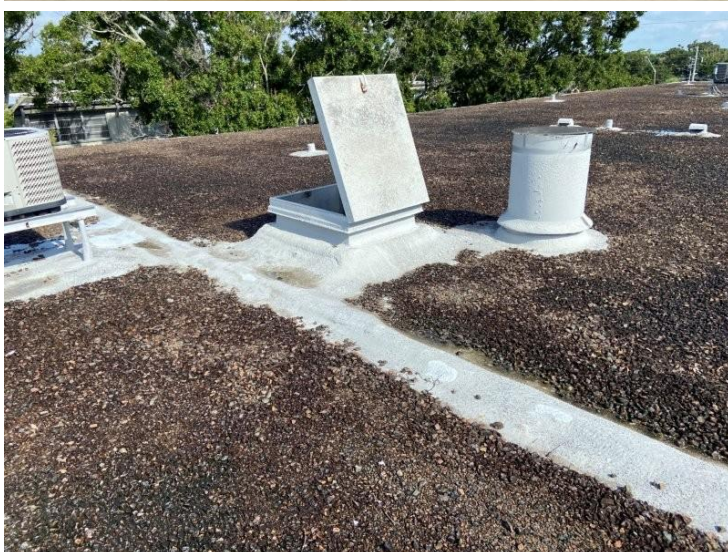
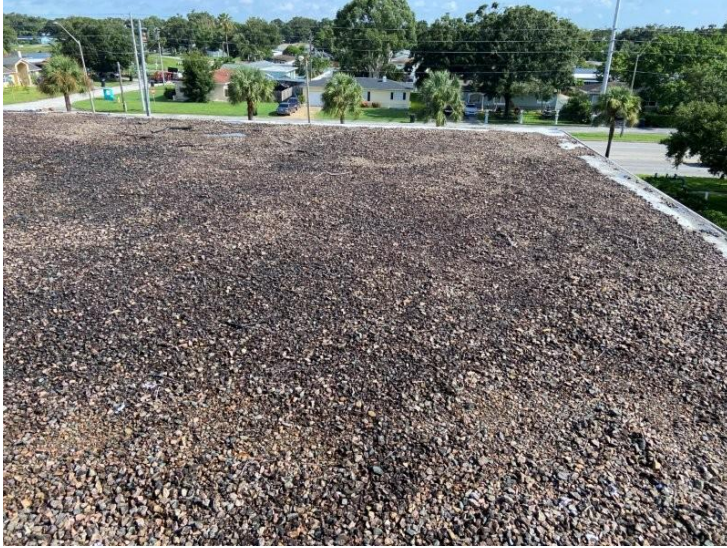
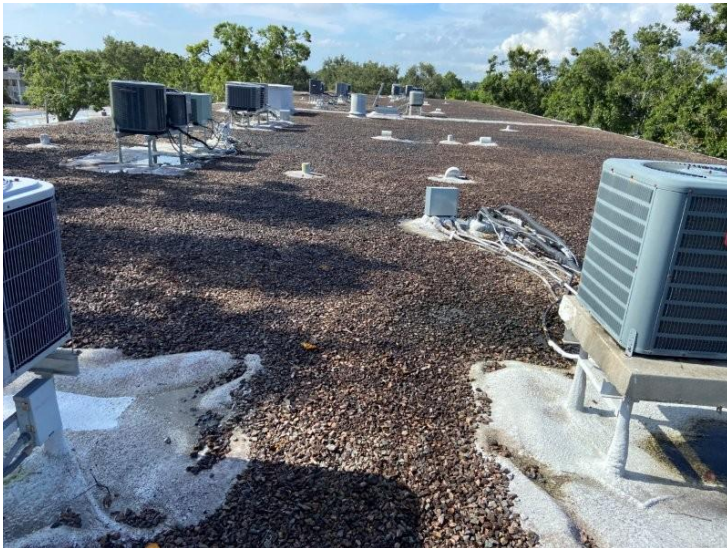
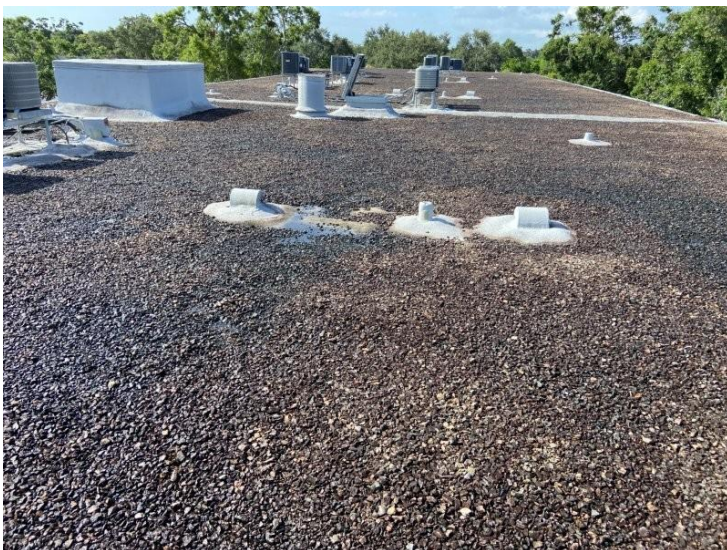
Roof Construction

| <b>3. Roof Deck Attachment:</b><br>Comments: | <b>Other</b><br>Inspection verified a roof deck composed of lightweight concrete supported by metal bar joists. |
| <b>4. Roof to Wall Attachment:</b><br>Comments: | <b>Structural</b><br>Inspection verified a roof-wall connection composed of steel bar joists structurally connected to the wall/support system. |
| <b>5. Roof Geometry:</b><br>Comments: | <b>Flat Roof</b><br>Inspection verified a flat roof shape. |
