## COMMERCIAL WINDSTORM MITIGATION REPORT

Parkwood Square Apartments Association B, Inc.

**COMMERCIAL WINDSTORM MITIGATION REPORT (OIR-B1-1802)**

5880 38th Ave N, Units 101-311

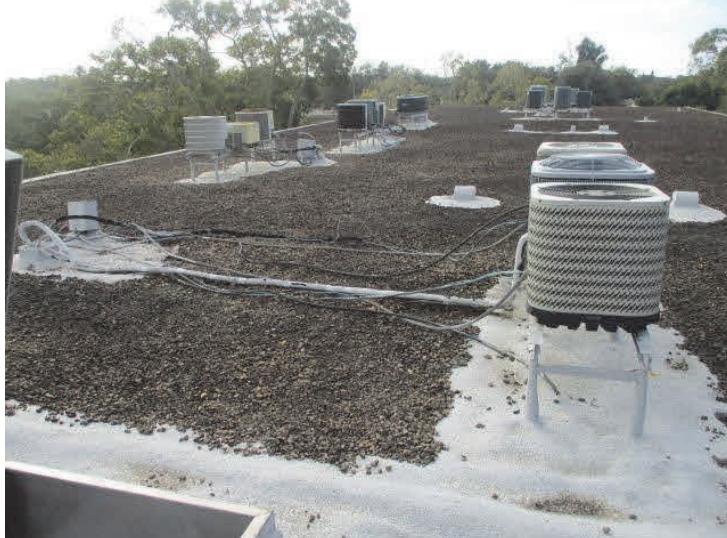
Exterior Elevation

- 5. Roof Geometry:**  
Comments: **Flat Roof**  
Inspection verified a flat roof shape.
- 6. SWR:**  
Comments: **No**  
No SWR verified at time of inspection.

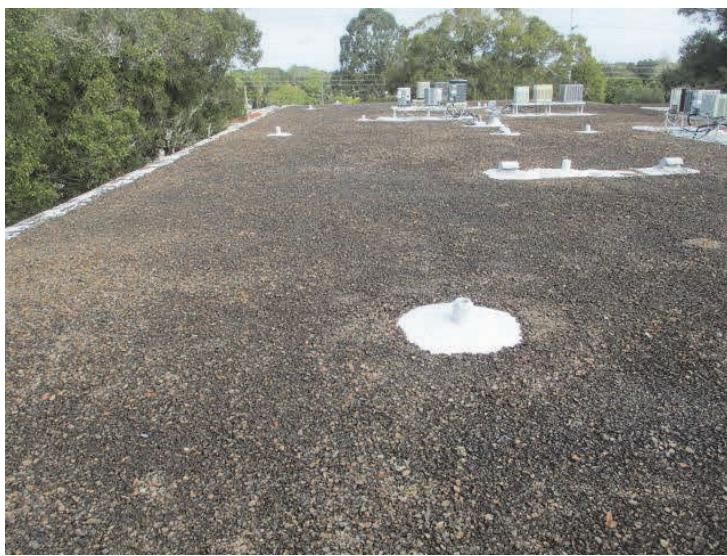
Roof Construction

- 3. Roof Deck Attachment:**  
Comments: **Other**  
Inspection verified a roof deck composed of lightweight concrete supported by metal bar joists.
- 4. Roof to Wall Attachment:**  
Comments: **Structural**  
Inspection verified a roof-wall connection composed of steel bar joists structurally connected to the wall/support system.
